**Flood Control Project Maintenance
Levee Inspections**
LMA District Cover Sheet
Spring 2019 Levee Inspection Results

Reclamation District No. 0556 Upper Andrus

Spring 2019 Levee Inspection Results

Waterway			Bank	Unit Miles
Unit No. 01 Georgiana Slough			Right	5.48
	Spring (March - May)	Summer (June - August)	(September - November) Fall	Winter (December - February)
Unit Maintenance Rating (Fall Only)				
Date of Inspection	3/21/2019 - 3/21/2019			
DWR Inspector	David Julian			
Accompanied By	Alan Silva Reclamation District 556

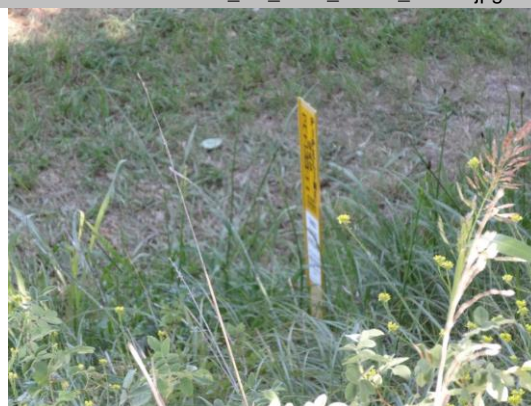
Photo 1 of 3 : UCIP_SP_2019_45564_74151.jpg

Gasline marker present on LS.

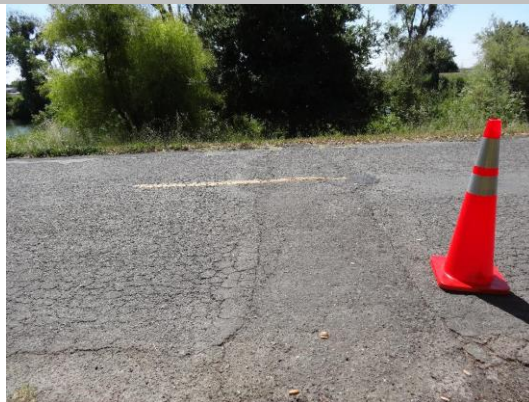
Photo 2 of 3 : UCIP_SP_2019_45664_74191.jpg

View of WS with cuts visible on pavement.

Comment Code						
Inspector Comment						
FS_ID:45664 DS_ID:20826 EP_NO: 5548A Repair Type: Non-Urgent Crossing Status: Found UCIP Comments: Dense vegetation prevented inspection of WS slope. FIELD_STRUCT_DESC: 14-inch steel irrigation discharge pipe through the levee, 5 feet below the crown. Pump on the waterside (WS). Electrical conduit through the levee at the same location. Pole with electrical panel at the landside (LS) toe. Standpipe at the LS toe. (Plans to install a 7-gauge, 14-inch pipe through the levee authorized under Permit No. 5548-A, 1981 - Kaydix Company). [Additional Reference(s): DWR Levee Log]. FS Date: 5/27/2015

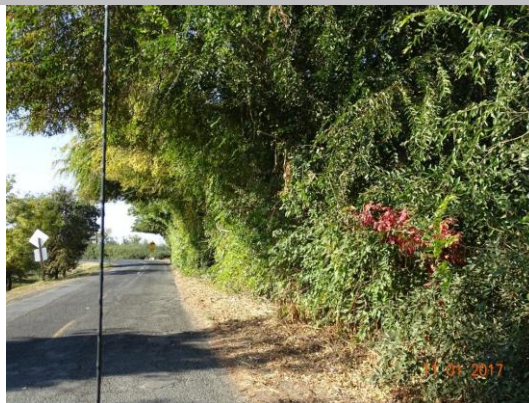
Photo 1 of 1 : SP_2019_RD0556_18_24_20190311_00006.jpg

LM Start	0.87	Rating **	U	Issue No.	24
LM End	0.92	Issue Type +	En	Location *	LS
Category	Earthen Levee			GPS Latitude/Longitude	
				Start	End
Item	Vegetation			38.228820 °	38.228480 °
				-121.525853 °	-121.526470 °
DWR ID	DWR_RD0556_01_f_2017_24				
Comment Code					
V6 : Landscaping					
Inspector Comment

Trim/thin landscaping to allow inspection and access to levee slope and toe.

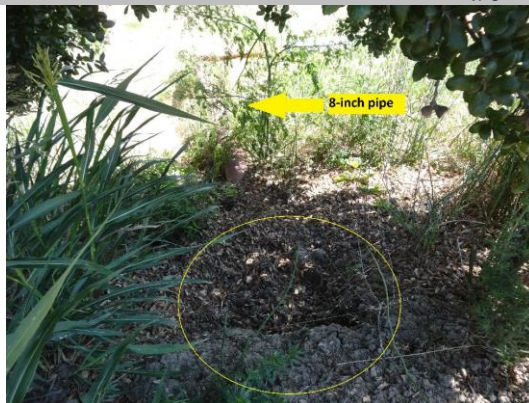
Photo 1 of 3 : UCIP_SP_2019_46799_74739.jpg

LM Start	1.17	Rating **	M	Issue No.	52
LM End	1.17	Issue Type +	En	Location *	
Category	Supplemental			GPS Latitude/Longitude	
				Start	End
Item	DWR UCIP Field Study			38.227534 °	38.227534 °
				-121.529396 °	-121.529396 °
DWR ID	25106				
Comment Code					
Inspector Comment					
FS_ID:46799 DS_ID:25106 EP_NO: N/A Repair Type: Non-Urgent Crossing Status: Found UCIP Comments: Possible erosion above pipe on LS needs attention. FIELD_STRUCT_DESC: 8-inch steel irrigation pipe through the levee, at an unknown depth. Visible on the landside (LS), 6 feet away from the 10-inch pipe at HLM 1.17. Post likely for protection of vent located on the shoulder. Power pole next to pipe on the LS. This crossing was field discovered. FS Date: 5/27/2015

LS view: 8-inch pipe off LS slope with possible erosion above pipe (circled).

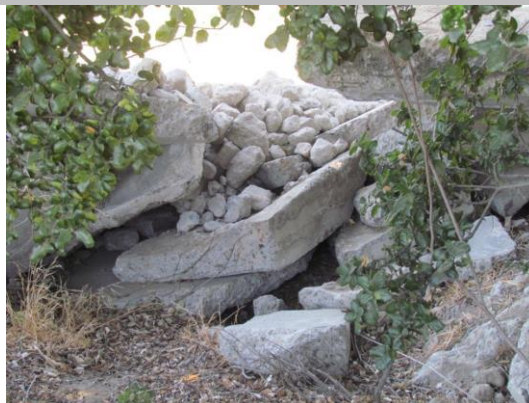
Photo 2 of 3 : SP_2019_RD0556_18_27_20190311_00010.jpg

RD 556 unit 1 levee miles 1.34-1.37 landside toe.

LM Start	1.34	Rating **	U	Issue No.	27 (cont)	
LM End	1.37	Issue Type +	En	Location *	LS	
Category	Earthen Levee			GPS Latitude/Longitude		
				Start		End
Item	Encroachments			38.227521 °		38.227320 °
				-121.532393 °		-121.532710 °
DWR ID	DWR_RD0556_01_s_2013_27					
Comment Code						
DE : Debris						
Inspector Comment						
Remove the pile of asphalt and concrete from the toe of levee.

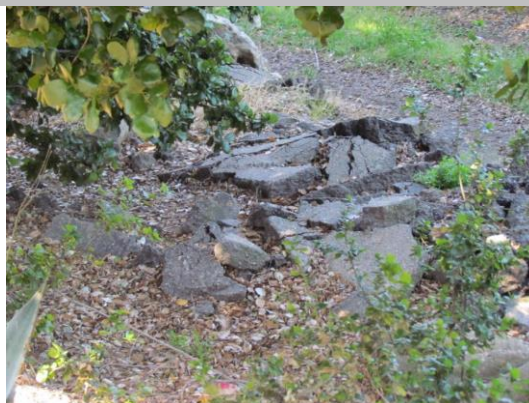
Photo 3 of 3 : SP_2019_RD0556_18_27_20190311_00011.jpg

RD 556 Unit 1 levee mile 1.34-1.37 continuation of material on the toe.

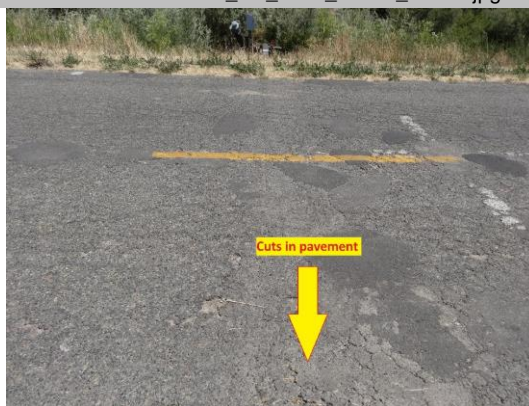
Photo 2 of 3 : UCIP_SP_2019_45786_74281.jpg

View toward WS with cuts in pavement in alignment with pipe on WS

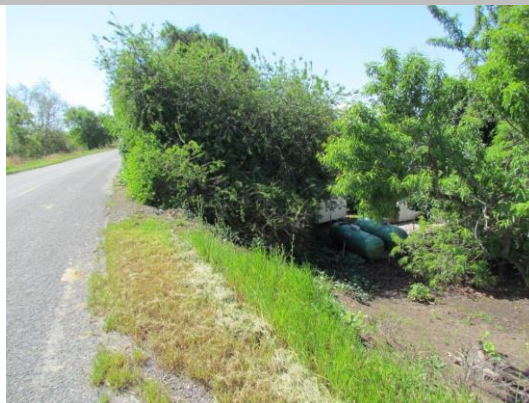
Photo 1 of 2 : SP_2019_RD0556_18_31_20190311_00015.jpg

LM Start	2.38	Rating **	U	Issue No.	31
LM End	2.43	Issue Type +	En	Location *	LS
Category	Earthen Levee			GPS Latitude/Longitude	
				Start	End
Item	Vegetation			38.219037 °	38.218342 °
				-121.543847 °	-121.543842 °
DWR ID	DWR_RD0556_01_s_2017_31				
Comment Code					
V6 : Landscaping					
Inspector Comment

Looking downstream from the landside shoulder woody tree growth blocking the slope and shoulder.

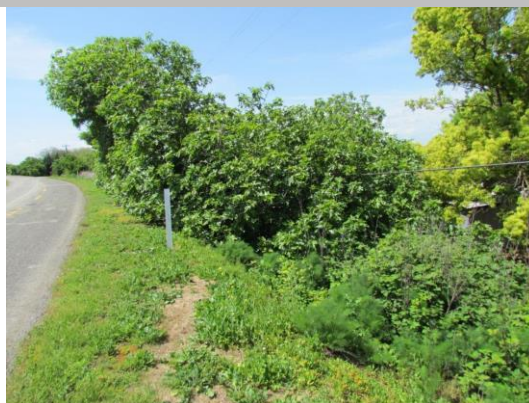
Photo 1 of 1 : SP_2019_RD0556_18_38_20190311_00022.jpg

556 Unit 1 levee mile 3.25-3.29 woody tree growth and vegetation blocking the view of the levee slope and toe.

LM Start	3.25	Rating **	U	Issue No.	38
LM End	3.29	Issue Type +	Ma	Location *	LS
Category	Earthen Levee			GPS Latitude/Longitude	
				Start	End
Item	Vegetation			38.210250 °	38.209842 °
				-121.540207 °	-121.540658 °
DWR ID	DWR_RD0556_01_s_2017_38				
Comment Code					
V7 : Trees / Woody Vegetation					
Inspector Comment					
Remove the wild tree growth and vegetation from the landside levee slope and toe so the ground can be seen.

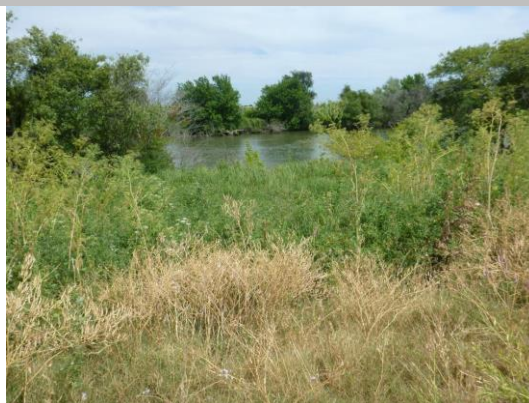
Photo 1 of 2 : SP_2019_RD0556_18_23_20190311_00004.jpg

LM Start	3.43	Rating **	A/W	Issue No.	23
LM End	3.75	Issue Type +	Ma	Location *	
Category	Supplemental			GPS Latitude/Longitude	
				Start	End
Item	2017 Storm Damage			38.208070 °	38.203400 °
				-121.541700 °	-121.540990 °
DWR ID	DWR_RD0556_01_f_2017_23				
Comment Code					
Inspector Comment					
Levee Evaluation Comments					
Description:					
Site ID No:67					
Site Designation:USACE_CESPK_UPA1_2011_p_0143					
Repair Type: Stability					
Rating:Area of Concern					
Field Date:2/7/2017					
Notes: inactive ditch on landside toe, slope covered in heavy vegetation, minor landside lower slope sloughing observed,

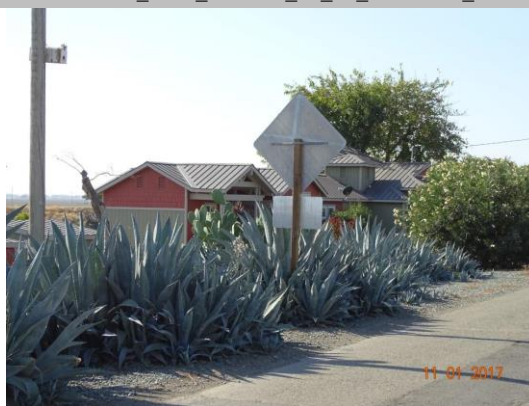
Photo 1 of 1 : SP_2019_RD0556_18_34_20190311_00019.jpg

View of large cactus on waterside shoulder

LM Start	3.93	Rating **	U	Issue No.	34
LM End	3.98	Issue Type +	En	Location *	WS
Category	Earthen Levee			GPS Latitude/Longitude	
				Start	End
Item	Vegetation			38.201603 °	38.201273 °
				-121.542352 °	-121.543328 °
DWR ID	DWR_RD0556_01_f_2017_34				
Comment Code					
V6 : Landscaping					
Inspector Comment					
Remove large cactus from waterside shoulder to allow inspection and access.

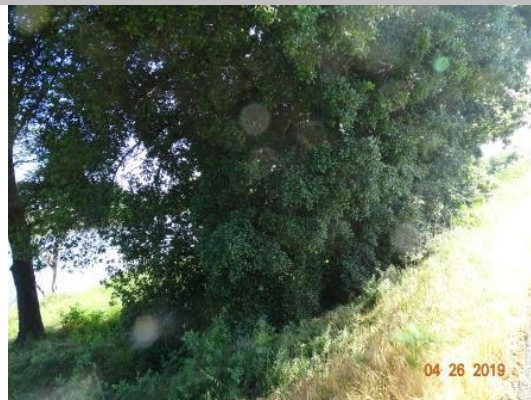
Photo 1 of 1 : SP_2019_RD0556_19_40_20190429_00084.jpg

View looking upstream at thick trees on the waterside slope (Spring 2019).

LM Start	0.44	Rating **	U	Issue No.	40
LM End	0.51	Issue Type +	Ma	Location *	WS
Category	Earthen Levee			GPS Latitude/Longitude	
				Start	End
Item	Trim / Thin Trees			38.238142 °	38.237900 °
				-121.526198 °	-121.527553 °
DWR ID	DWR_RD0556_02_f_2018_40				
Comment Code					
T1 : Trim trees to at least five feet above ground level.					
Inspector Comment

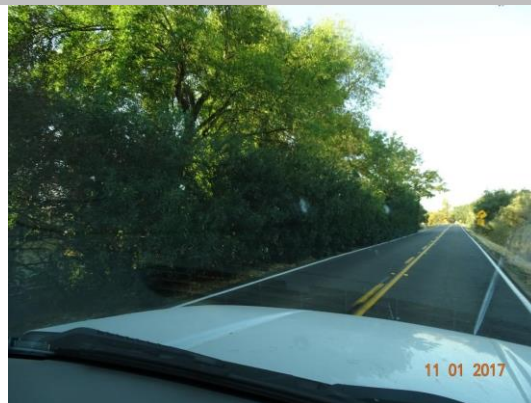
Photo 1 of 1 : SP_2019_RD0556_19_25_20190311_00009.jpg

View of oleanders on the landside of the levee.

LM Start	0.55	Rating **	M	Issue No.	25
LM End	0.55	Issue Type +	En	Location *	LS
Category	Earthen Levee			GPS Latitude/Longitude	
				Start	End
Item	Vegetation			38.237810 °	38.237810 °
				-121.528182 °	-121.528182 °
DWR ID	DWR_RD0556_02_f_2017_25				
Comment Code					
V6 : Landscaping					
Inspector Comment					
Trim/thin oleanders on the landside of the levee.

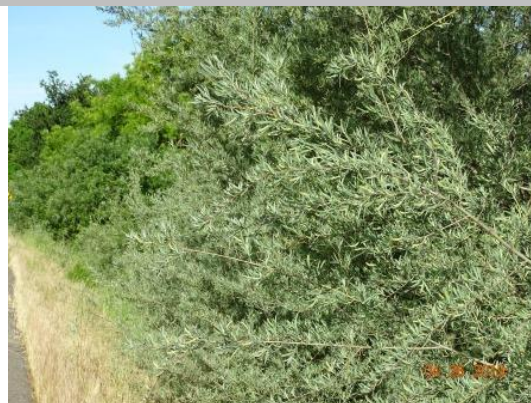
Photo 1 of 1 : SP_2019_RD0556_19_51_20190429_00083.jpg

View looking downstream at wildgrowth on the waterside slope (Spring 2019).

LM Start	0.58	Rating **	U	Issue No.	51
LM End	0.89	Issue Type +	Ma	Location *	WS
Category	Earthen Levee			GPS Latitude/Longitude	
				Start	End
Item	Vegetation			38.237712 °	38.238005 °
				-121.528657 °	-121.534400 °
DWR ID	DWR_RD0556_02_f_2018_51				
Comment Code					
V2 : Remove the wild growth other than native grasses from the levee slopes.					
Inspector Comment					
Remove wildgrowth 20' down the waterside slope.

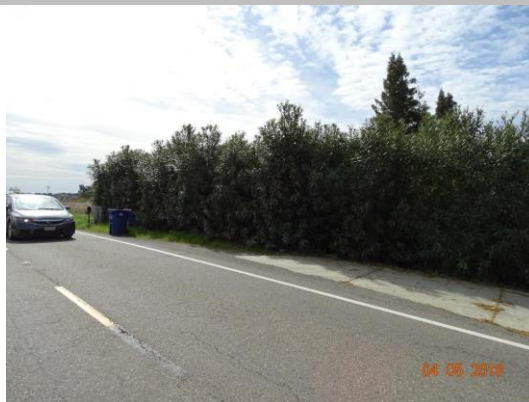
Photo 1 of 1 : SP_2019_RD0556_19_26_20190311_00010.jpg

LM Start	1.14	Rating **	U	Issue No.	26
LM End	1.14	Issue Type +	En	Location *	LS
Category	Earthen Levee			GPS Latitude/Longitude	
				Start	End
Item	Vegetation			38.239005 °	38.239005 °
				-121.538772 °	-121.538772 °
DWR ID	DWR_RD0556_02_f_2017_26				
Comment Code					
V6 : Landscaping					
Inspector Comment					
Trim/thin oleanders on the landside of the levee.

Manage oleanders to allow inspection and access.

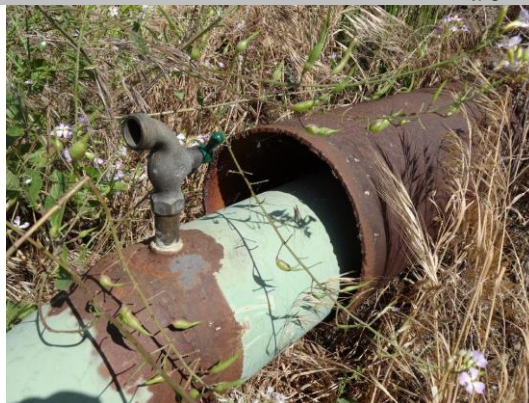
Photo 2 of 3 : UCIP_SP_2019_12573_20380.jpg

LS- 6-inch steel pipe sleeved through 10-inch steel pipe. 6" pipe is attached with air release valve.

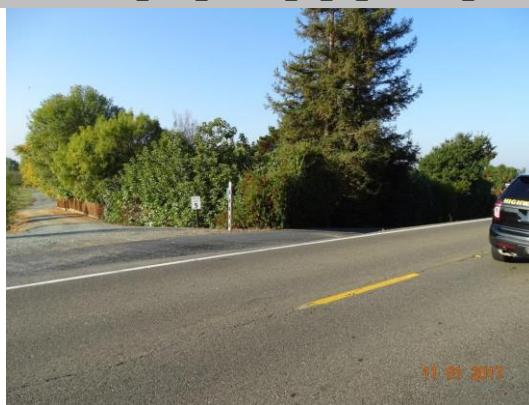
Photo 1 of 1 : SP_2019_RD0556_19_28_20190311_00012.jpg

View of oleanders on the landside of the levee.

LM Start	1.31	Rating **	U	Issue No.	28
LM End	1.31	Issue Type +	En	Location *	LS
Category	Earthen Levee			GPS Latitude/Longitude	
				Start	End
Item	Vegetation			38.239677 °	38.239677 °
				-121.541715 °	-121.541716 °
DWR ID	DWR_RD0556_02_f_2017_28				
Comment Code					
V6 : Landscaping					
Inspector Comment					
Trim/thin oleanders on the landside of the levee.

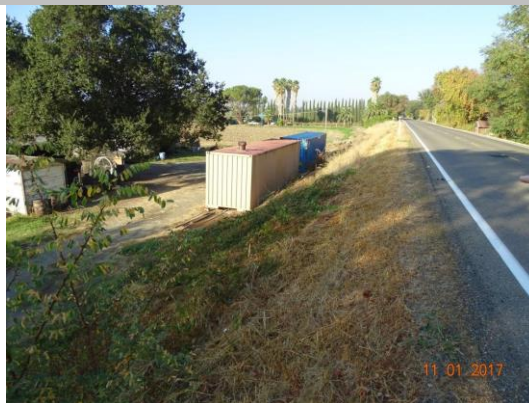
Photo 1 of 1 : SP_2019_RD0556_19_29_20190311_00013.jpg

View of two large sea-train shipping containers at the landside toe.

LM Start	1.39	Rating **	U	Issue No.	29
LM End	1.39	Issue Type +	En	Location *	LS
Category	Earthen Levee			GPS Latitude/Longitude	
				Start	End
Item	Encroachments			38.239935 °	38.239935 °
				-121.543148 °	-121.543148 °
DWR ID	DWR_RD0556_02_f_2017_29				
Comment Code					
EQ : Equipment					
Inspector Comment					
Remove/relocate the two large sea-train shipping containers to at least 10 feet from the landside toe to allow inspection and access.

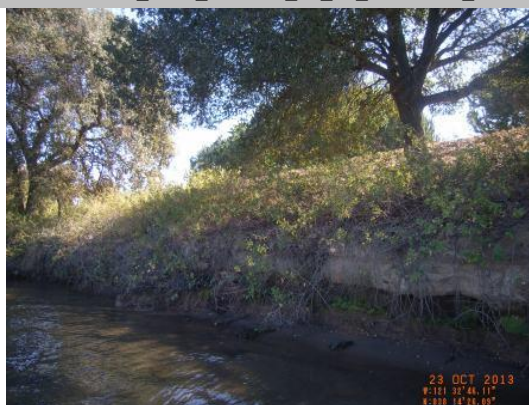
Photo 1 of 1 : SP_2019_RD0556_19_18_20190311_00006.jpg

LM Start	1.45	Rating **	M	Issue No.	18
LM End	1.59	Issue Type +	Ma	Location *	WS
Category	Supplemental			GPS Latitude/Longitude	
				Start	End
Item	2017 USACE Erosion Survey, DRAFT			38.240401 °	38.240772 °
				-121.544106 °	-121.546791 °
DWR ID	DWR_RD0556_02_f_2018_18				
Comment Code					
Inspector Comment					
2017 Site ID: SAC 24.8 L					
Status: Eroding					
2017 Field Notes: Significant lower bank erosion.					
Site History: 1997 - Slow erosion of the berm at the waterline; bench below water. 2005 - Brush boxes present. 2010 - Minor new erosion.					
2013 - There is little to no berm remaining at downstream end of this site. 2016 - New erosion on levee slope.

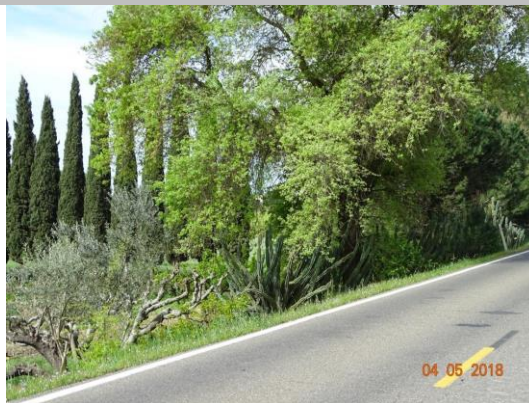
Photo 1 of 1 : SP_2019_RD0556_19_41_20190311_00023.jpg

View of cactus and other landscaping.

LM Start	1.48	Rating **	U	Issue No.	41
LM End	1.48	Issue Type +	En	Location *	LS
Category	Earthen Levee			GPS Latitude/Longitude	
				Start	End
Item	Vegetation			38.240212 °	38.240212 °
				-121.544719 °	-121.544719 °
DWR ID	DWR_RD0556_02_s_2018_41				
Comment Code					
V6 : Landscaping					
Inspector Comment					
Cactus and other landscaping should be removed and managed to allow access and inspection.

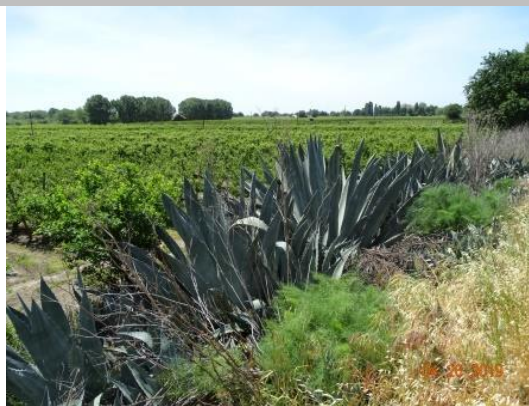
Photo 1 of 1 : SP_2019_RD0556_19_47_20190429_00092.jpg

LM Start	1.57	Rating **	U	Issue No.	47
LM End	1.57	Issue Type +	Ma	Location *	LS
Category	Earthen Levee			GPS Latitude/Longitude	
				Start	End
Item	Vegetation			38.240455 °	38.240455 °
				-121.546362 °	-121.546362 °
DWR ID	DWR_RD0556_02_s_2019_47				
Comment Code					
V2 : Remove the wild growth other than native grasses from the levee slopes.					
Inspector Comment					
Remove cactus from the landside slope.

View looking downstream at cactus on the landside slope (Spring 2019).

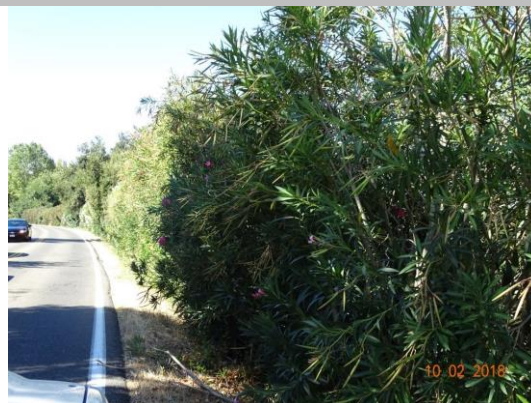
Photo 1 of 1 : SP_2019_RD0556_19_70_20190311_00034.jpg

LM Start	1.82	Rating **	U	Issue No.	70
LM End	1.92	Issue Type +	En	Location *	WS
Category	Earthen Levee			GPS Latitude/Longitude	
				Start	End
Item	Vegetation			38.241010 °	38.240618 °
				-121.551033 °	-121.552747 °
DWR ID	DWR_RD0556_02_f_2018_70				
Comment Code					
V6 : Landscaping					
Inspector Comment					
Thin oleanders to allow view down the levee slope.

View looking downstream at oleanders (October 2018).

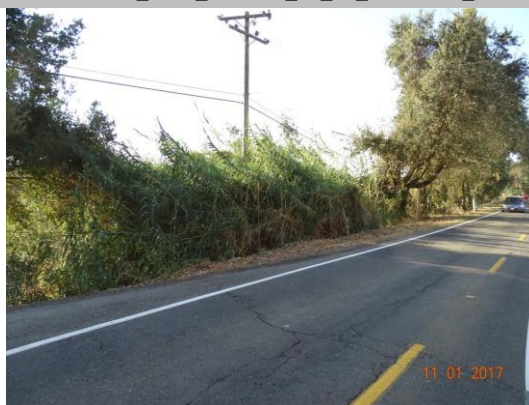
Photo 1 of 1 : SP_2019_RD0556_19_32_20190311_00016.jpg

LM Start	2.06	Rating **	U	Issue No.	32
LM End	2.06	Issue Type +	Ma	Location *	LS
Category	Earthen Levee			GPS Latitude/Longitude	
				Start	End
Item	Vegetation			38.239470 °	38.239470 °
				-121.554845 °	-121.554845 °
DWR ID	DWR_RD0556_02_f_2017_32				
Comment Code					
V2 : Remove the wild growth other than native grasses from the levee slopes.					
Inspector Comment					
Arundo growth should be removed to allow inspection and access to the landside slope and toe.

View of arundo on the landside slope and toe.

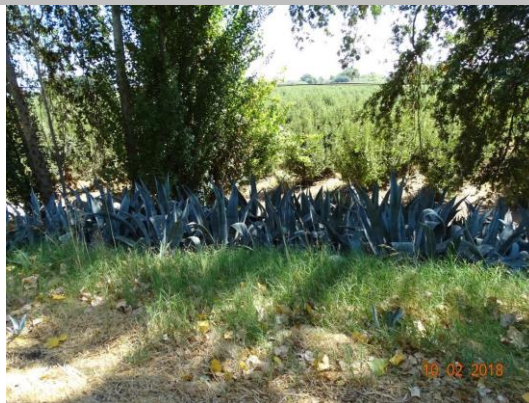
Photo 1 of 1 : SP_2019_RD0556_19_87_20190311_00044.jpg

LM Start	2.13	Rating **	U	Issue No.	87
LM End	2.13	Issue Type +	En	Location *	LS
Category	Earthen Levee			GPS Latitude/Longitude	
				Start	End
Item	Vegetation			38.238780 °	38.238780 °
				-121.555717 °	-121.555717 °
DWR ID	DWR_RD0556_02_f_2018_87				
Comment Code					
V6 : Landscaping					
Inspector Comment					
Cactus should be removed from the landside slope.

View of cactus on the landside slope (October 2018).

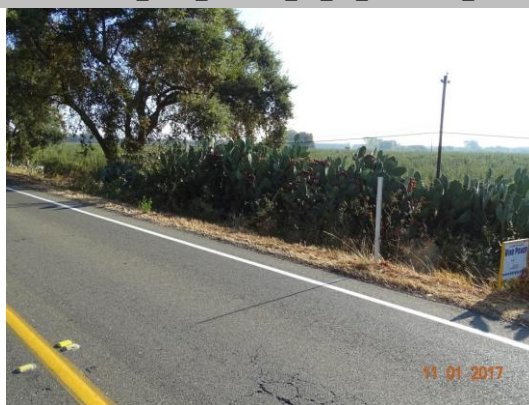
Photo 1 of 1 : SP_2019_RD0556_19_33_20190311_00017.jpg

LM Start	2.22	Rating **	U	Issue No.	33
LM End	2.22	Issue Type +	En	Location *	LS
Category	Earthen Levee			GPS Latitude/Longitude	
				Start	End
Item	Vegetation			38.237883 °	38.237883 °
				-121.556958 °	-121.556958 °
DWR ID	DWR_RD0556_02_f_2017_33				
Comment Code					
V6 : Landscaping					
Inspector Comment					
Large growth of prickly pear cactus should be removed to allow inspection and access.

View of large growth of prickly pear cactus.

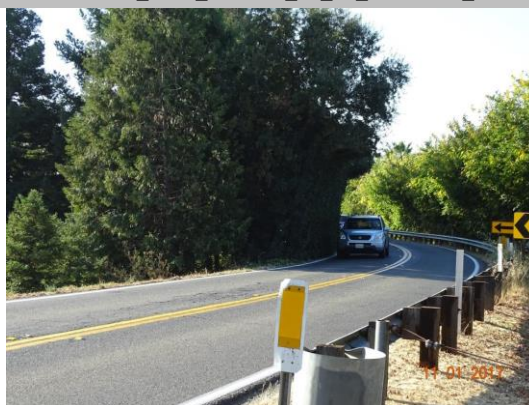
Photo 1 of 1 : SP_2019_RD0556_19_35_20190311_00019.jpg

LM Start	2.29	Rating **	U	Issue No.	35
LM End	2.29	Issue Type +	En	Location *	LS
Category	Earthen Levee			GPS Latitude/Longitude	
				Start	End
Item	Vegetation			38.237060 °	38.237060 °
				-121.557782 °	-121.557782 °
DWR ID	DWR_RD0556_02_f_2017_35				
Comment Code					
V6 : Landscaping					
Inspector Comment					
Trim/thin oleanders to allow inspection and access to landside slope and toe.

View of oleanders on the landside slope and toe.

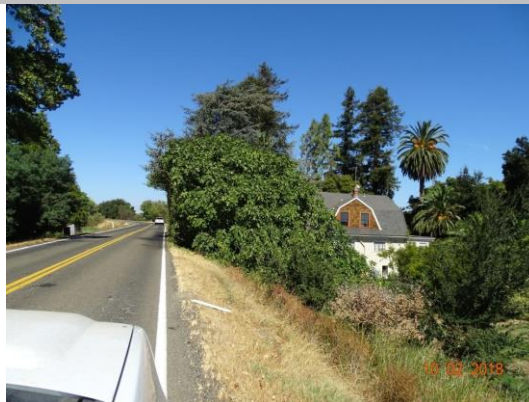
Photo 1 of 1 : SP_2019_RD0556_19_46_20190311_00024.jpg

LM Start	2.29	Rating **	M	Issue No.	46
LM End	2.86	Issue Type +	En	Location *	LS
Category	Earthen Levee			GPS Latitude/Longitude	
				Start	End
Item	Vegetation			38.236980 °	38.229195 °
				-121.557782 °	-121.555337 °
DWR ID	DWR_RD0556_02_f_2018_46				
Comment Code					
V6 : Landscaping					
Inspector Comment

View looking upstream at beginning of landscaping on landside (October 2018).

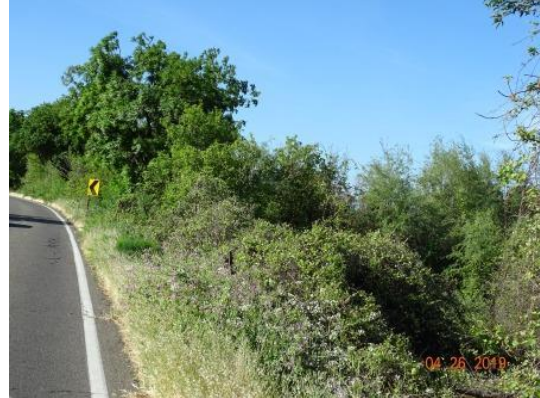
Photo 1 of 1 : SP_2019_RD0556_19_21_20190429_00085.jpg

LM Start	2.34	Rating **	U	Issue No.	21
LM End	2.79	Issue Type +	Ma	Location *	WS
Category	Earthen Levee			GPS Latitude/Longitude	
				Start	End
Item	Vegetation			38.236317 °	38.230230 °
				-121.557996 °	-121.555689 °
DWR ID	DWR_RD0556_02_s_2019_21				
Comment Code					
V2 : Remove the wild growth other than native grasses from the levee slopes.					
Inspector Comment					
Remove wildgrowth 20' down the waterside slope.

View looking downstream at thick wildgrowth on the waterside shoulder (Spring 2019).

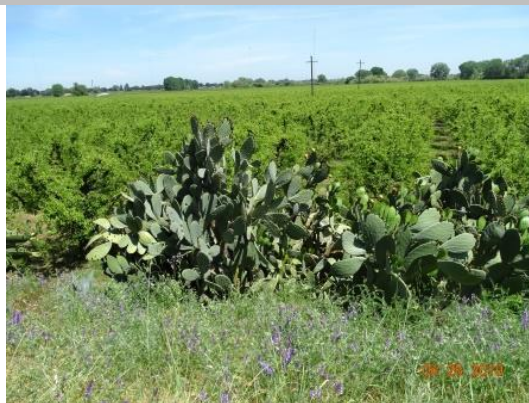
Photo 1 of 1 : SP_2019_RD0556_19_45_20190429_00091.jpg

LM Start	2.43	Rating **	U	Issue No.	45
LM End	2.43	Issue Type +	Ma	Location *	LS
Category	Earthen Levee			GPS Latitude/Longitude	
				Start	End
Item	Vegetation			38.235036 °	38.235036 °
				-121.558011 °	-121.558011 °
DWR ID	DWR_RD0556_02_s_2019_45				
Comment Code					
V2 : Remove the wild growth other than native grasses from the levee slopes.					
Inspector Comment					
Remove cactus from the landside slope.

View of cactus on the landside slope (Spring 2019).

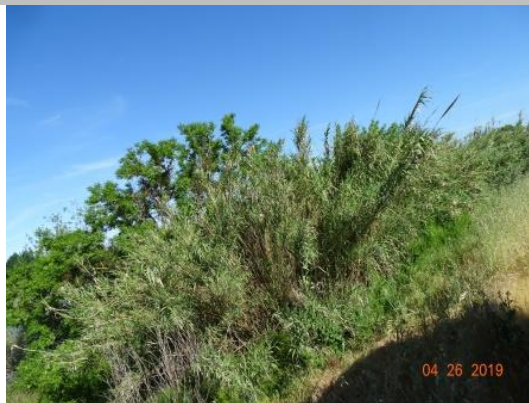
Photo 2 of 2 : SP_2019_RD0556_19_76_20190429_00089.jpg

LM Start	2.90	Rating **	U	Issue No.	76 (cont)	
LM End	5.71	Issue Type +	Ma	Location *	WS	
Category	Earthen Levee			GPS Latitude/Longitude		
				Start		End
Item	Vegetation			38.228683 °		38.191822 °
				-121.555352 °		-121.567455 °
DWR ID	DWR_RD0556_02_f_2018_76					
Comment Code						
V2 : Remove the wild growth other than native grasses from the levee slopes.						
Inspector Comment						
Remove vegetation 20' from the waterside slope including patches of arundo.

View looking upstream at arundo on the waterside slope (Spring 2019).

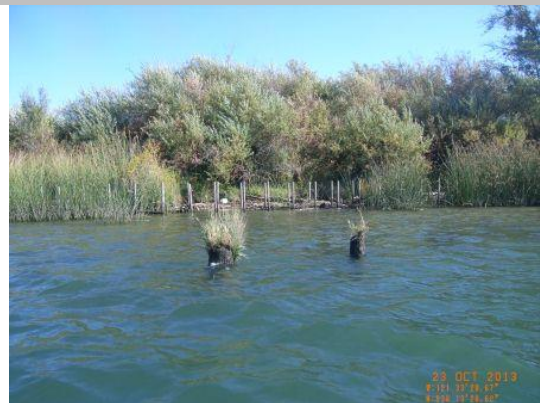
Photo 1 of 1 : SP_2019_RD0556_19_17_20190311_00005.jpg

LM Start	3.17	Rating **	M	Issue No.	17
LM End	3.28	Issue Type +	Ma	Location *	WS
Category	Supplemental			GPS Latitude/Longitude	
				Start	End
Item	2017 USACE Erosion Survey, DRAFT			38.224850 °	38.223233 °
				-121.555641 °	-121.555687 °
DWR ID	DWR_RD0556_02_f_2018_17				
Comment Code					
Inspector Comment					
2017 Site ID: SAC 23.2 L					
Status: Eroding					
2017 Field Notes: New erosion along lower bank.					
Site History: 2000 - Recently fallen cottonwood at the downstream end.					
2005 - Empty brush boxes. 2011 - A few trees have fallen since last year.					
2012 - Potential new tree popout since last year. 2013 - New erosion at downstream end of site and a recent tree pop-out observed.					
2016 - New erosion at the toe.

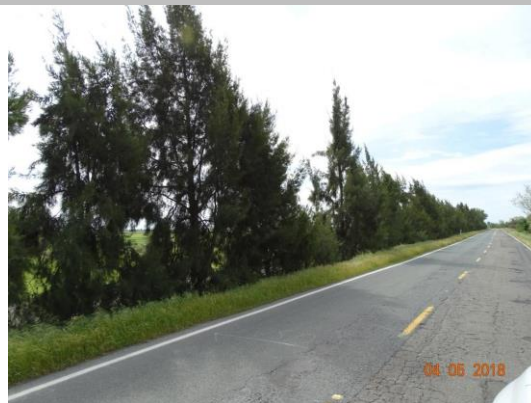
Photo 1 of 1 : SP_2019_RD0556_19_49_20190311_00025.jpg

LM Start	3.58	Rating **	U	Issue No.	49
LM End	3.74	Issue Type +	En	Location *	LS
Category	Earthen Levee			GPS Latitude/Longitude	
				Start	End
Item	Vegetation			38.218889 °	38.216543 °
				-121.556388 °	-121.556777 °
DWR ID	DWR_RD0556_02_s_2018_49				
Comment Code					
V6 : Landscaping					
Inspector Comment					
A row of evergreen trees block inspection and access. They should be trimmed to 5' above the levee.

View of landscaping trees on the landside.

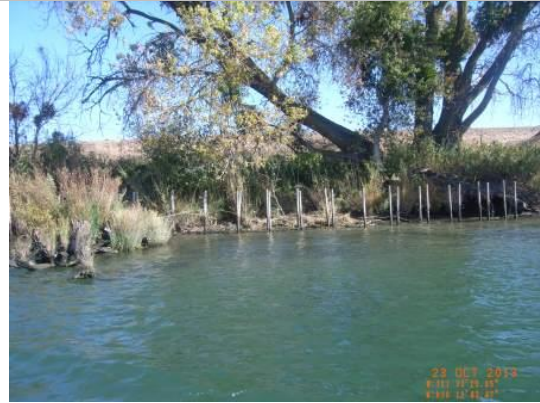
Photo 1 of 1 : SP_2019_RD0556_19_15_20190311_00003.jpg

LM Start	3.95	Rating **	M	Issue No.	15
LM End	4.12	Issue Type +	Ma	Location *	WS
Category	Supplemental			GPS Latitude/Longitude	
				Start	End
Item	2017 USACE Erosion Survey, DRAFT			38.213581 °	38.211112 °
				-121.557197 °	-121.557042 °
DWR ID	DWR_RD0556_02_f_2018_15				
Comment Code					
Inspector Comment					
2017 Site ID: SAC 22.5 L					
Status: Eroding					
2017 Field Notes: New lower bank erosion at the upstream end. Locals placed rock in some erosion pockets.					
Site History: 2002 - Spot rock along berm, but not in the erosion pockets. 2005 - Some new minor stone revetment at the upstream end. Brush boxes present. 2006 - Currently installing new brush in downstream brush boxes. 2007 - Rock in middle portion for about 150 ft. 2010 - Some attempt at repairs but still has pockets of erosion. 2012 - More erosion along the toe.

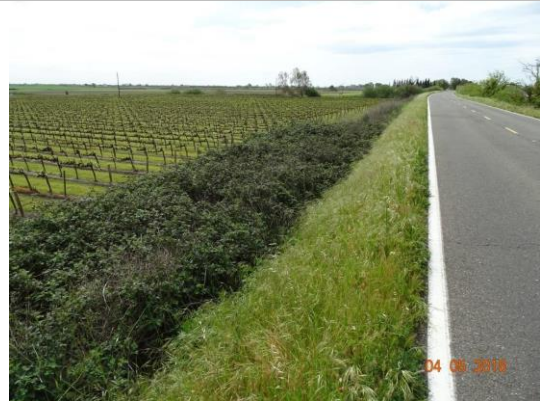
Photo 1 of 1 : SP_2019_RD0556_19_52_20190311_00026.jpg

LM Start	4.01	Rating **	U	Issue No.	52
LM End	4.38	Issue Type +	Ma	Location *	LS
Category	Earthen Levee			GPS Latitude/Longitude	
				Start	End
Item	Vegetation			38.212662 °	38.207293 °
				-121.556808 °	-121.556837 °
DWR ID	DWR_RD0556_02_s_2018_52				
Comment Code					
V2 : Remove the wild growth other than native grasses from the levee slopes.					
Inspector Comment					
Remove berry vines on the landside to allow inspection and access.

View of berry vines on landside.

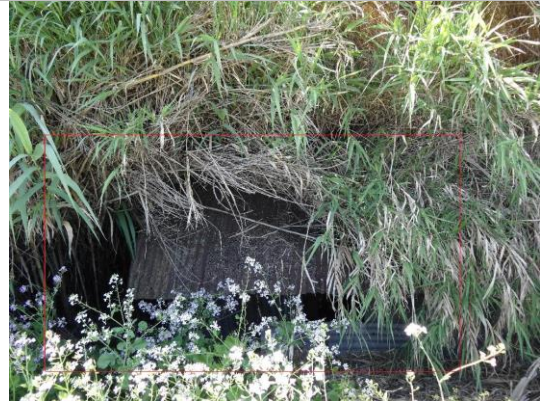
Photo 2 of 3 : UCIP_SP_2019_12545_20309.jpg

WS- pump house inside the dense vegetation.

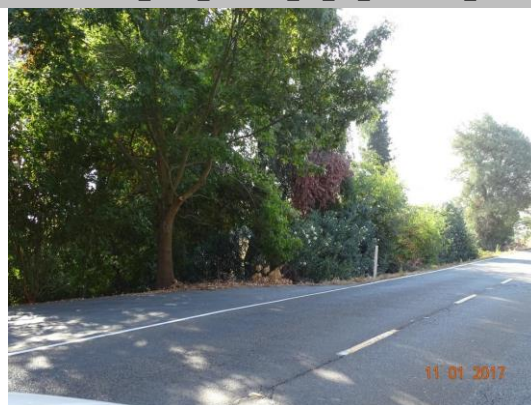
Photo 1 of 1 : SP_2019_RD0556_19_36_20190311_00020.jpg

LM Start	4.41	Rating **	M	Issue No.	36
LM End	4.41	Issue Type +	En	Location *	LS
Category	Earthen Levee			GPS Latitude/Longitude	
				Start	End
Item	Vegetation			38.206915 °	38.206915 °
				-121.556818 °	-121.556818 °
DWR ID	DWR_RD0556_02_f_2017_36				
Comment Code					
V6 : Landscaping					
Inspector Comment					
Oleanders, trees, and other landscaping should be trimmed to allow inspection and access to the landside slope and toe.

View of landscaping on the landside.

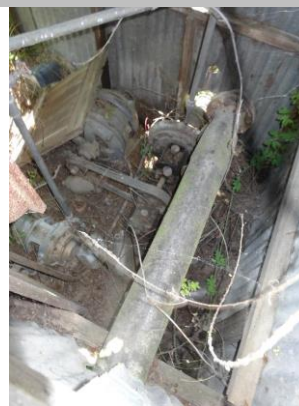
Photo 3 of 3 : UCIP_SP_2019_12546_20315.jpg

WS- abandoned gate valve, pump, and pipe in pump house

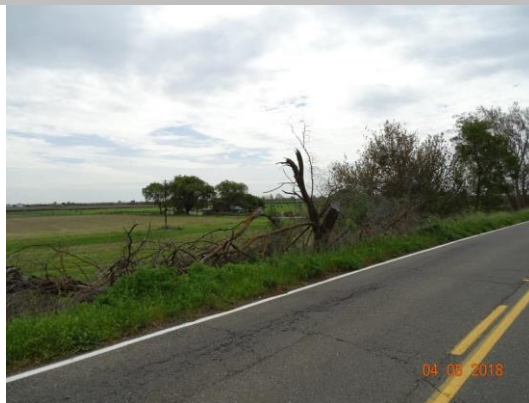
Photo 1 of 1 : SP_2019_RD0556_19_56_20190311_00029.jpg

LM Start	4.56	Rating **	N	Issue No.	56
LM End	4.56	Issue Type +	Ma	Location *	LS
Category	Earthen Levee			GPS Latitude/Longitude	
				Start	End
Item	Trim / Thin Trees			38.204666 °	38.204666 °
				-121.556813 °	-121.556813 °
DWR ID	DWR_RD0556_02_s _ 2018_56				
Comment Code					
T5 : Tree stumps.					
Inspector Comment					
Large stumps are on the landside.

Fallen tree on landside should be removed.

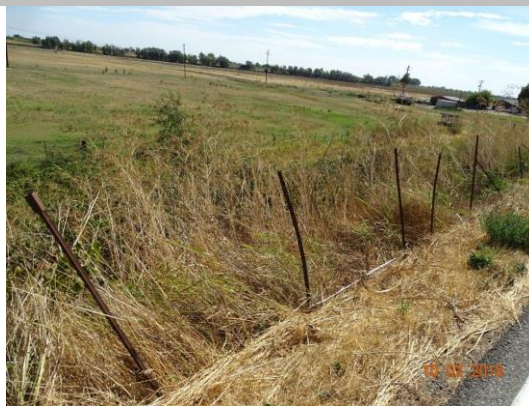
Photo 1 of 1 : SP_2019_RD0556_19_38_20190311_00022.jpg

LM Start	4.63	Rating **	M	Issue No.	38
LM End	4.84	Issue Type +	En	Location *	LS
Category	Earthen Levee			GPS Latitude/Longitude	
				Start	End
Item	Encroachments			38.203693 °	38.200593 °
				-121.556683 °	-121.557208 °
DWR ID	DWR_RD0556_02_s _ 2012_38				
Comment Code					
FE : Fence					
Inspector Comment					
Remove this old fence from the levee section landside.

View of old fence posts on landside slope (October 2018).

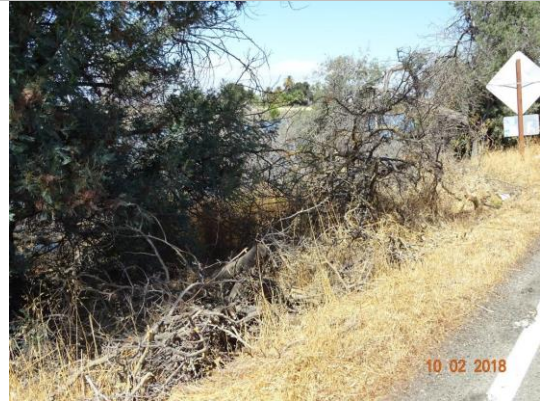
Photo 1 of 1 : SP_2019_RD0556_19_27_20190311_00011.jpg

LM Start	4.65	Rating **	M	Issue No.	27
LM End	4.65	Issue Type +	Ma	Location *	WS
Category	Earthen Levee			GPS Latitude/Longitude	
				Start	End
Item	Encroachments			38.203425 °	38.203425 °
				-121.556845 °	-121.556845 °
DWR ID	DWR_RD0556_02_s_2017_27				
Comment Code					
TR : Tree or limb					
Inspector Comment					
Remove fallen tree from the waterside slope.

View of fallen tree on the waterside slope (October 2018).

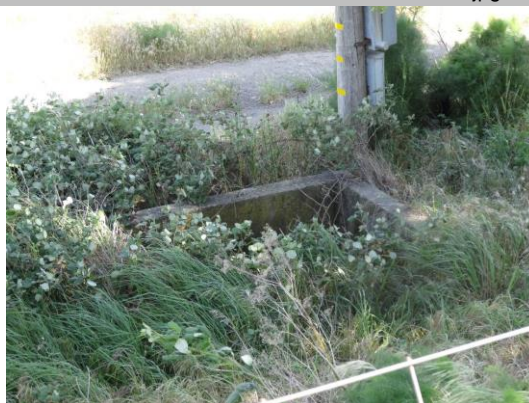
Photo 3 of 3 : UCIP_SP_2019_12547_20318.jpg

Comment Code						
Inspector Comment						
FS_ID:12547 DS_ID:20867 EP_NO: 11199 Repair Type: Non-Urgent Crossing Status: Indicator Found UCIP Comments: - pump, gate valve and pumphouse not found on waterward slope.- an abandoned electric control panel found on WS.- may need to be properly abandoned. FIELD_STRUCT_DESC: 6-inch steel irrigation discharge pipe through the levee, 6.5 feet below the crown. Siphon and concrete spill box with two 8-inch openings. (Retention of a 6-inch pipe through the levee, 6.5 feet below the crown, a pump and a gate valve in a pump house on the waterside [WS] slope, and a siphon breaker and a service pole on the landside [LS] slope authorized under Automatic Board Order (ABO) issued as Permit No. 11199, 1975 - Toshi Tokuyoshi, et al.). [Additional Reference(s): DWR Levee Log. USACE Sacramento O&M Manual 103, June 1954, (Station ""H"" 159+97), invert elevation 17.9 feet]. FS Date: 4/25/2013

LS- power pole and a concrete distribution box near levee toe.

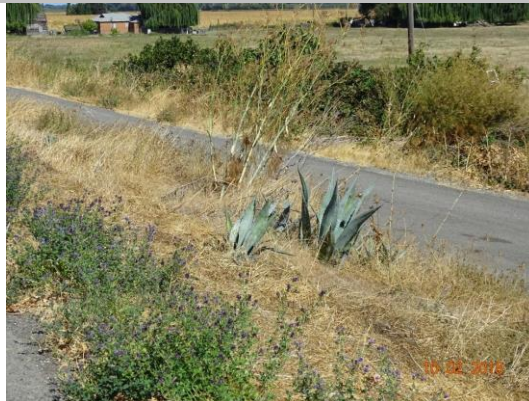
Photo 1 of 1 : SP_2019_RD0556_19_60_20190311_00032.jpg

LM Start	4.79	Rating **	M	Issue No.	60
LM End	4.79	Issue Type +	En	Location *	LS
Category	Earthen Levee			GPS Latitude/Longitude	
				Start	End
Item	Vegetation			38.201402 °	38.201402 °
				-121.557108 °	-121.557108 °
DWR ID	DWR_RD0556_02_s_2018_60				
Comment Code					
V6 : Landscaping					
Inspector Comment					
Remove cactus before more can become established.

View of cactus on the landside slope (October 2018).

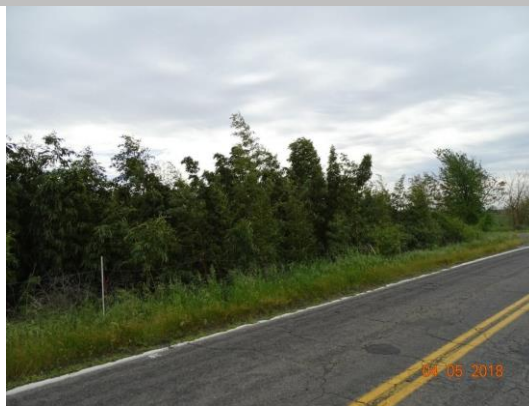
Photo 1 of 1 : SP_2019_RD0556_19_61_20190311_00033.jpg

LM Start	4.82	Rating **	U	Issue No.	61
LM End	4.82	Issue Type +	En	Location *	LS
Category	Earthen Levee			GPS Latitude/Longitude	
				Start	End
Item	Vegetation			38.201002 °	38.201002 °
				-121.557170 °	-121.557170 °
DWR ID	DWR_RD0556_02_s_2018_61				
Comment Code					
V6 : Landscaping					
Inspector Comment					
Landside bamboo should be removed to allow inspection and access.

View of landside bamboo.

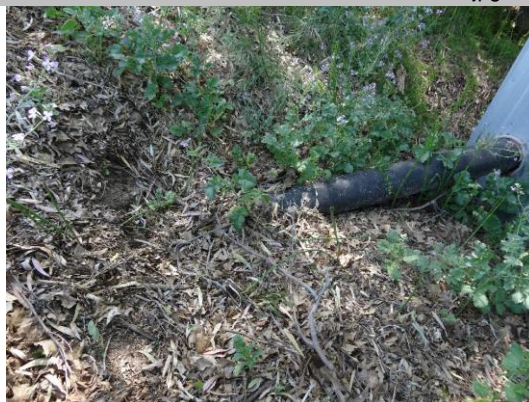
Photo 2 of 3 : UCIP_SP_2019_52733_20363.jpg

Comment Code					
Inspector Comment					
FS_ID:52733 DS_ID:20869 EP_NO: 11185 Repair Type: Urgent Crossing Status: Found UCIP Comments: 07/12/2018 Pit on WS is covered with plywood. Water pump is running, no leaks detected. LS part of crossing was reconstructed. New pipe was installed after CMP riser to supply water to sand filters. Remains Urgent due to large pit on WS that needs to be backfilled. (O.Yakimov-DWR UCIP)04/25/2013 Large pit on levee berm. FIELD_STRUCT_DESC: 8-inch irrigation discharge pipe of an unknown material through the levee, 5.7 feet below the crown. Pump and gate valve in a pump house on the waterside (WS) slope. Siphon breaker, concrete box, and service pole on the landside (LS) slope. (Retention of an 8-inch pipe through the levee, 5.7 feet below the crown, a pump and a gate valve in a pump house on the WS slope, and a siphon breaker and a service pole on the LS slope authorized under Automatic Board Order (ABO) issued as Permit No. 11185, 1975 - R. Walter Langhart). [Additional Reference(s): DWR Levee Log]. FS Date: 7/13/2018

WS- pipe daylight from the levee.

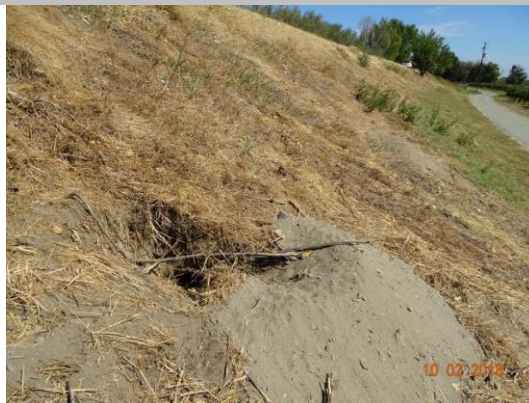
Photo 1 of 1 : SP_2019_RD0556_19_79_20190311_00038.jpg

LM Start	5.64	Rating **	U	Issue No.	79
LM End	5.64	Issue Type +	Ma	Location *	LS
Category	Earthen Levee			GPS Latitude/Longitude	
				Start	End
Item	Animal Control			38.192237 °	38.192237 °
				-121.566368 °	-121.566368 °
DWR ID	DWR_RD0556_02_f_2018_79				
Comment Code					
A3 : No rodents visible, but rodent burrows visible; need to backfill and compact or grout burrows.					
Inspector Comment					
More than 2 cubic feet of soil was removed between the two large burrow holes.

View looking upstream at burrow holes on land side slope. (October 2018).
